ARMY CONCEPT TEAM IN VIETNAM
APO SAN FRANCISCO 96384

FINAL REPORT

"IROQUOIS NIGHT FIGHTER AND NIGHT TRACKER"
(INFANT)

ACTIV Project No. ACA-49/67IS

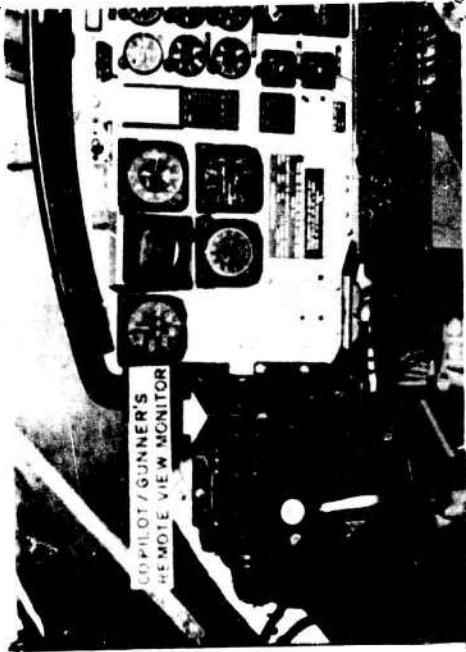
FIGURE 1-3. Copilot/Gunner's Remote View Monitor

(3) The LLLTV picture presented by the remote view subsystem is displayed to the pilot on an 8-inch video monitor to the right of his instrument panel (Figure 1-2), and to the copilot to the left of his instrument panel (Figure 1-3). A 14-inch video monitor in the rear cabin enables an observer to assist in detecting and recognizing targets (Figure 1-4). The space below the monitor is occupied by the data processing electronics for the AN/ASQ-132 subsystem. A hand control located on the helicopter pedestal is used for pointing the remote-view TV sensor which may be turned $\pm 70^\circ$ in traverse and $+15$ to -80° in elevation (Figure 1-5).

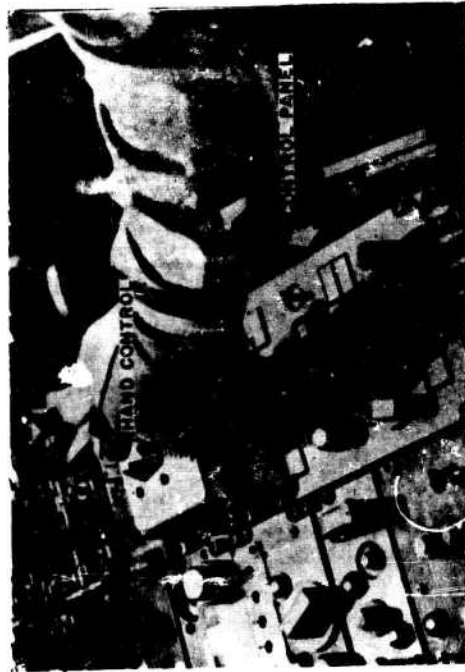
FIGURE 1-5. Hand Control and Control Panel

(6) The control panel for the AN/ASQ-132 is located on the helicopter pedestal between the pilot and copilot (Figure 1-5). It contains the on-off switches and various mode and adjustment controls required for system operation.

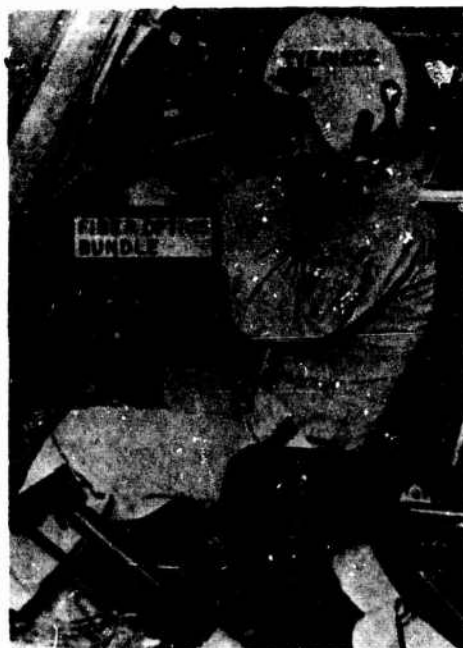
FIGURE 1-6. Copilot/Gunner's Eyepiece and Fiber Optic Bundle

(4) The display for the direct-view image intensifier subsystem is a monocular eyepiece attached to a 9-foot fiber optic bundle (Figure 1-6). When not in use, this display is stowed on the doorframe to the left of the copilot/gunner. When used, the eyepiece is attached to the M6 Sighting Station. This subsystem is separately energized. The sighting of the direct view subsystem may be operated independently of the remote view subsystem or, if desired, both sensors can be slaved together to follow the commands from the M6 sight.

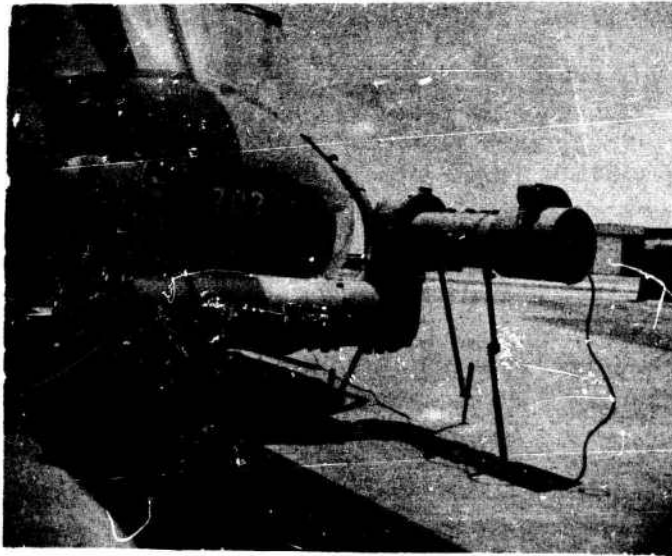
FIGURE 1-7. Viewer Test Kit Coupled to Remote View Periscope

A major component of ground support equipment provided as special test equipment is the viewer test kit for the AN/ASQ-132. The kit is furnished in its own rugged carrying and storage chest. The viewer test kit housing is a two piece tube. The two pieces of the tube telescope to provide changes of focus (apparent range to target). It stands on three adjustable legs and attaches to the remote or direct view periscope windows by means of an adapter that provides a light-proof fit for the test kit. The optical equipment inside the kit consists of a lamp, spectral band pass filter, adjustable attenuating filter wheel, light diffuser, target chart (Figure 1-8) and a three-element objective (collimating) lens. A voltage-regulating circuit is provided to power the lamp. Power is supplied from the helicopter battery. The tests

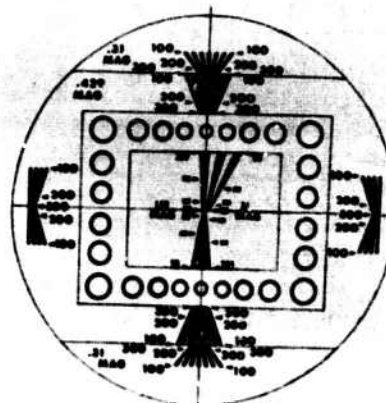
FIGURE 1-8. Viewer Test Kit Target Chart

performed with the viewer test kit are for:

- (1) Magnification
- (2) Focus
- (3) Distortion
- (4) High Light Level Resolution
- (5) Low Light Level Resolution
- (6) Video Signal Level
- (7) Automatic Light Control Response.

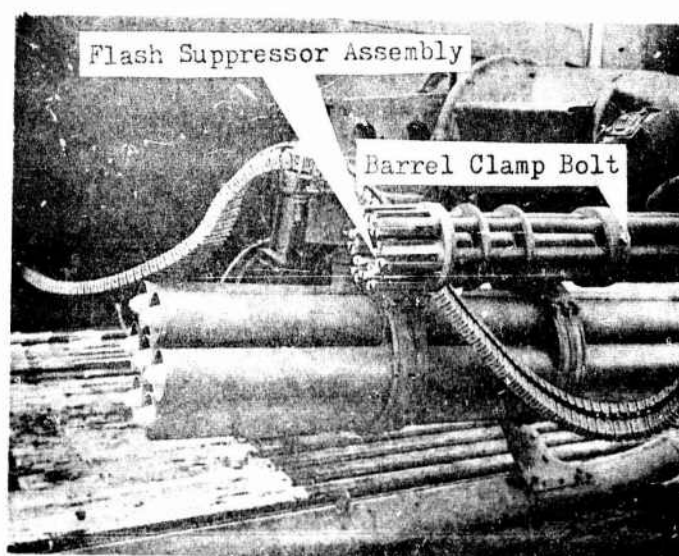
FIGURE 1-9. M134 Automatic Gun Flash Suppressor

Rock Island Arsenal. The suppressor is being procured under a limited production type classification. The suppressor assembly, P/N C11691135, manufactured by Mathewson Tool Company, Orange, Connecticut under DA contract DAA-F01-07-Q-1899, consists of three subassemblies: Nut, flash suppressor, P/N C11691129; Bolt, flash suppressor, P/N C11691128; and Suppressor, cluster, P/N C11691134. The suppressor cluster is an investment casting containing five protruding fingers for each barrel muzzle (see Figure 1-9). The cluster is attached to the gun by a bolt running from the center of the cluster flange down between the six barrels to the gun's barrel clamp where it is secured with the nut. The nut has a hole perpendicular to its axis which permits the barrel clamp bolt to pass through it, thereby locking it in place.

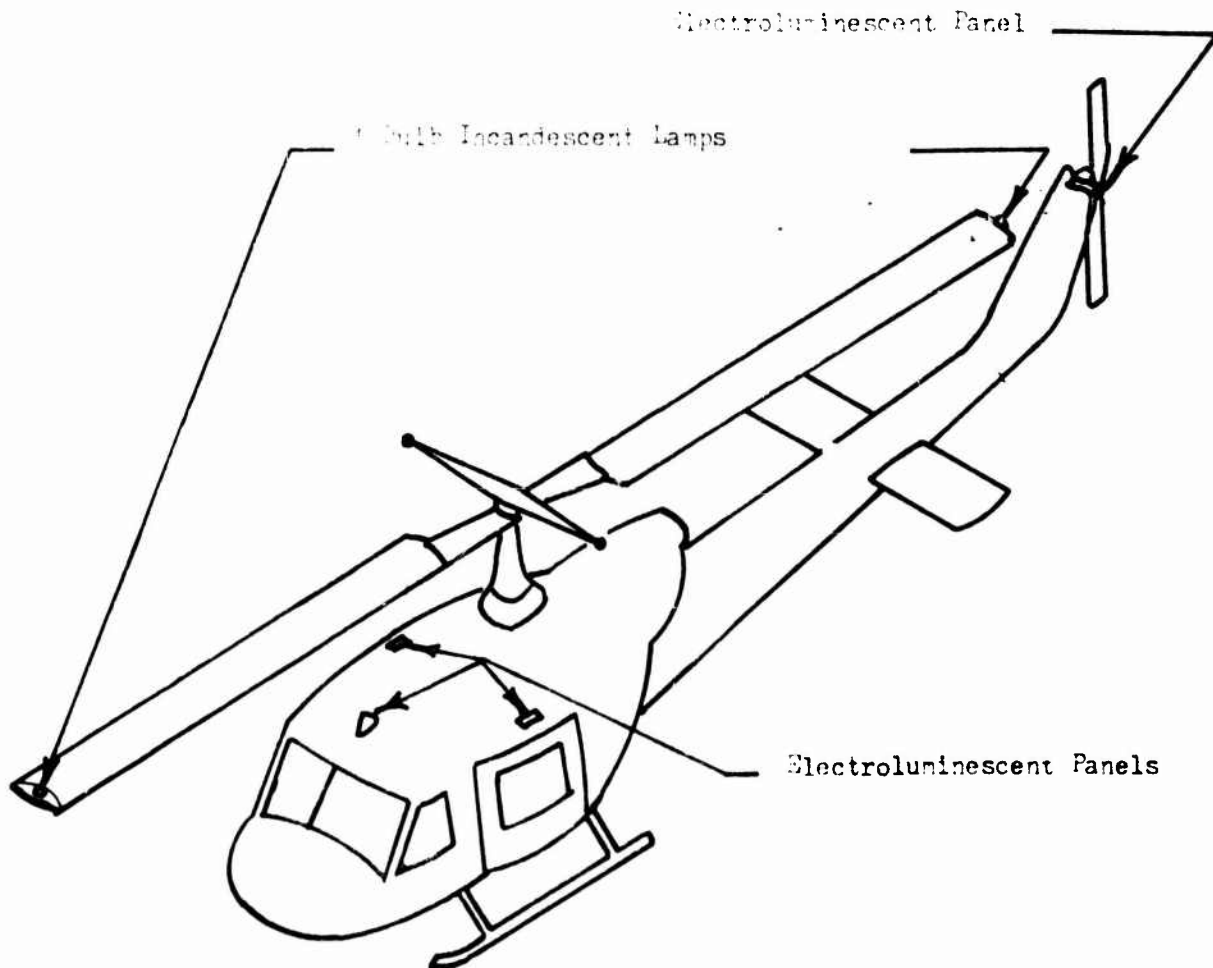
FIGURE 1-10. Location of Formation Lights

INFANT aircraft were outfitted with a non-standard US Navy Formation Light Kit similar in configuration and characteristics to a system previously evaluated by ACTIV (see references 1j and 11). The formation lights consist of four electroluminescent light panels with an illuminated surface area of approximately 6 square inches (located along the upper fuselage profile); two incandescent multi-bulb, lamp fixtures (one on each outboard rotor tip); and appropriate controls (located on the cockpit ceiling) (see Figure 1-10).

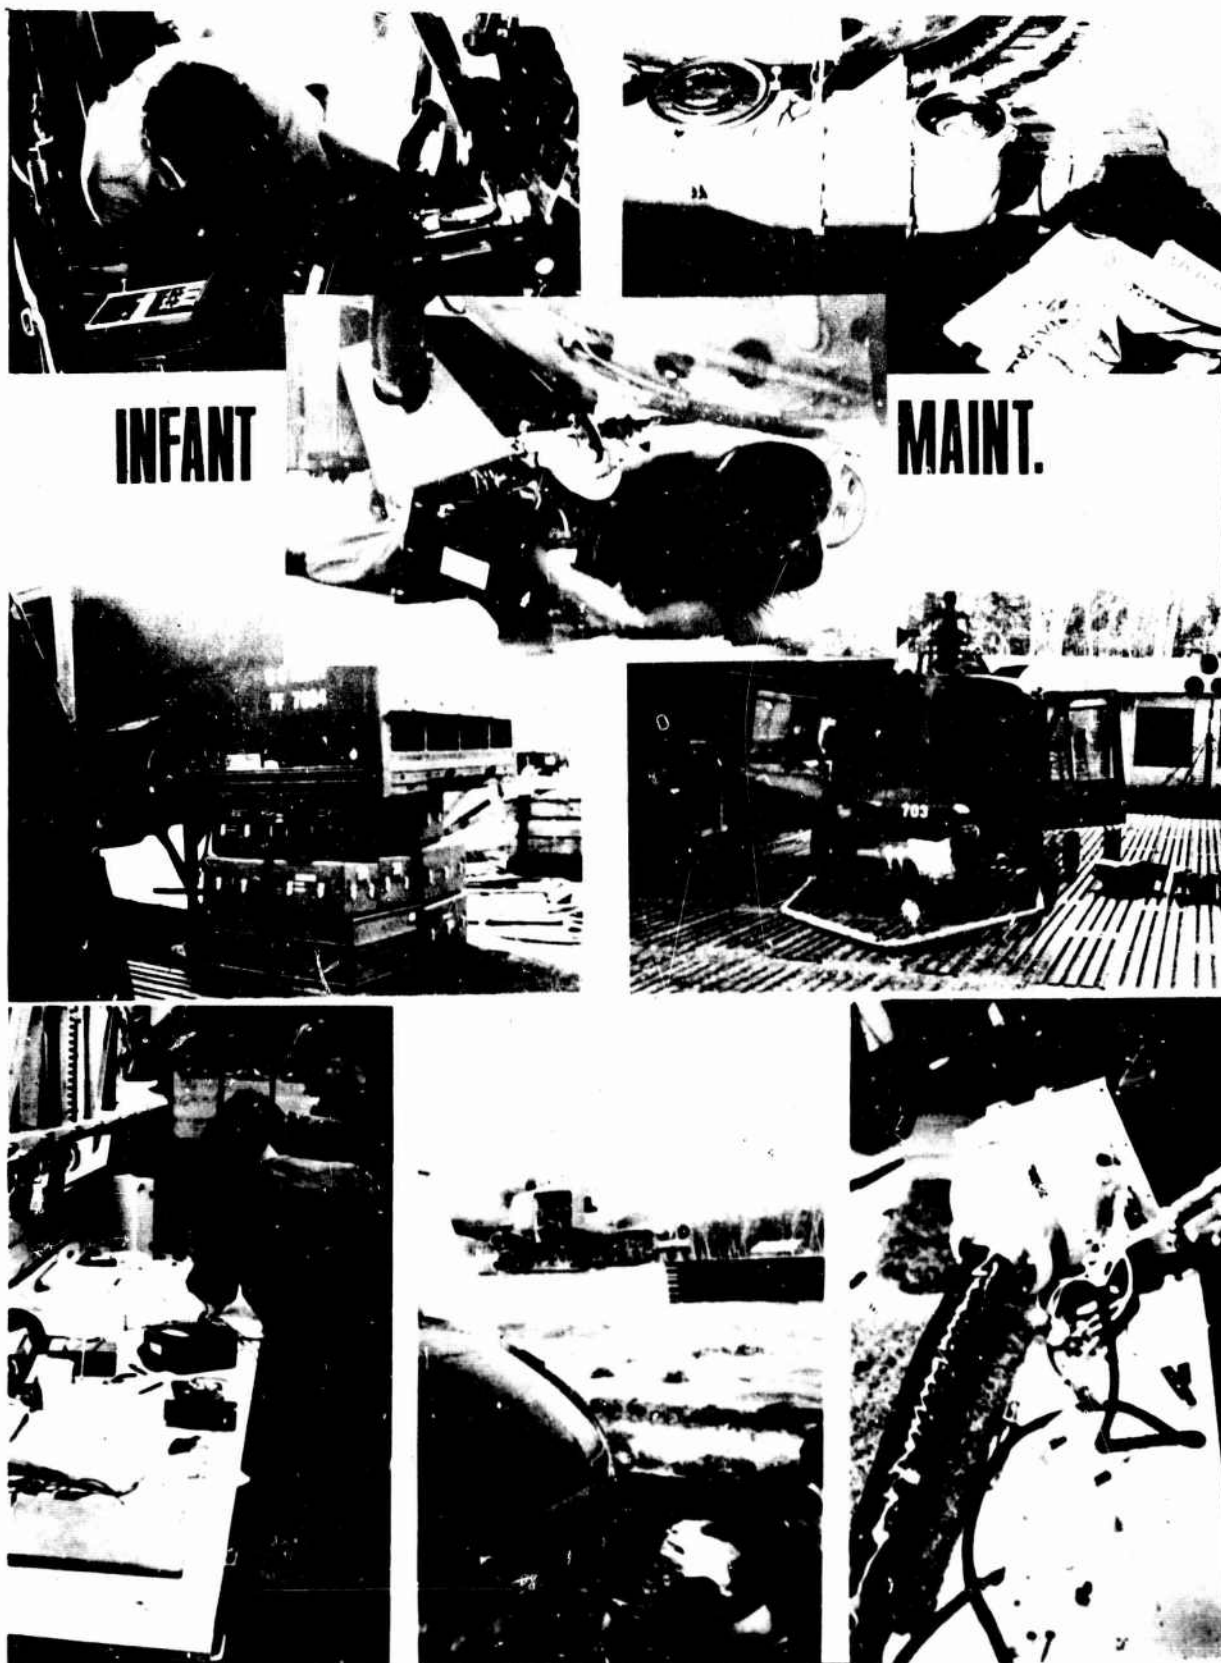
FIGURE 3-1. INFANT Maintenance (Montage)

20. (U) SYSTEM MAINTAINABILITY AND RELIABILITY (Figure 3-1)

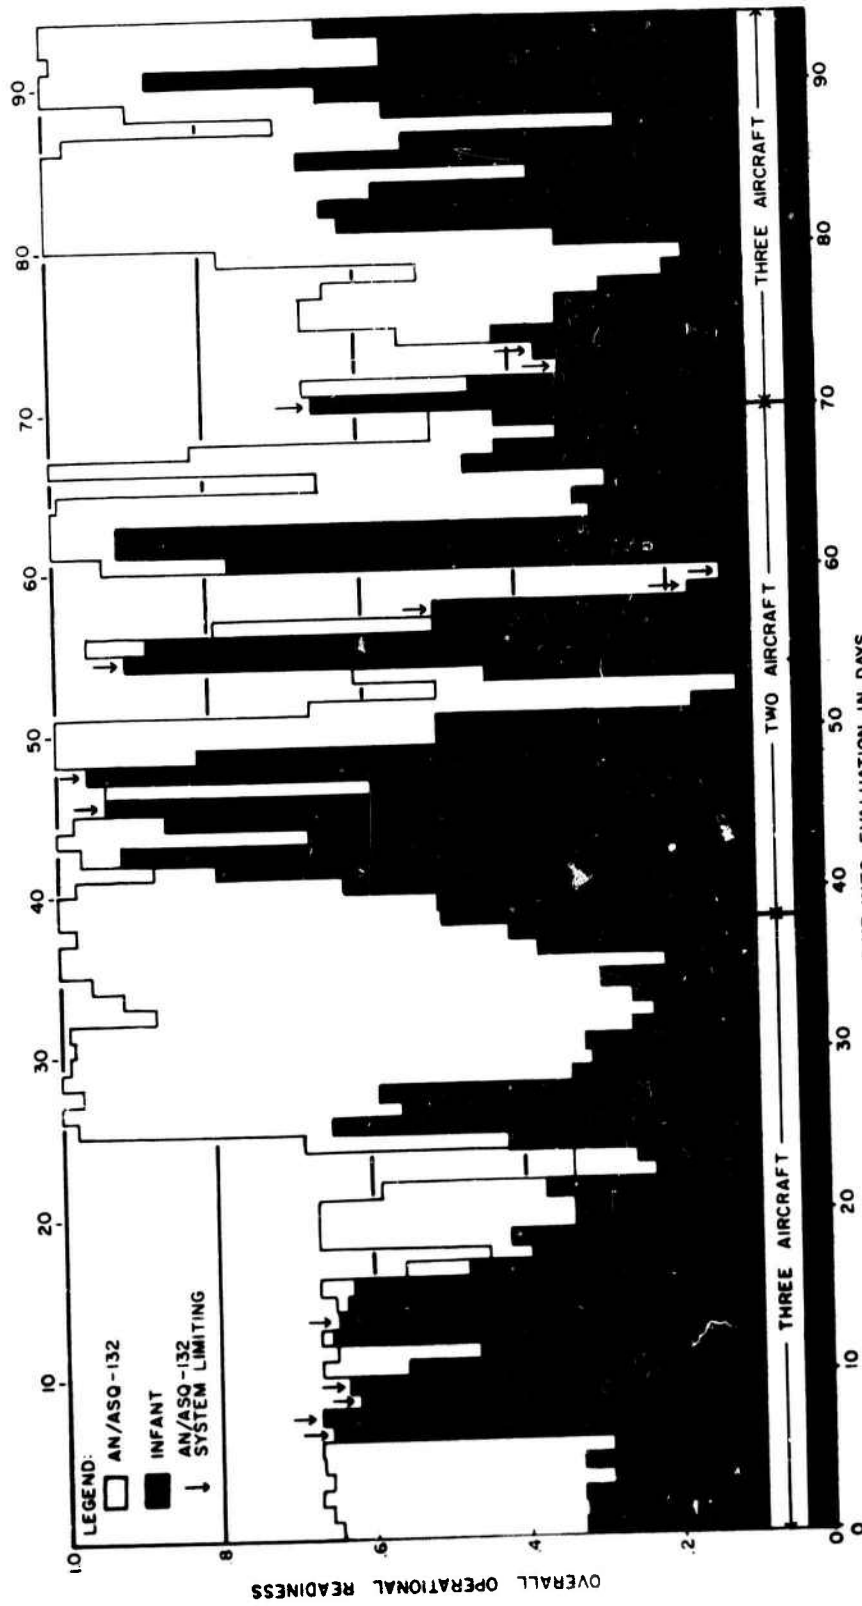
FIGURE 3-2. (U) Operational Readiness (OR)

(3) Availability of INFANT for each night's mission was determined as of 1700 hours each day. The overall mission availability (all subsystems operational) was 49% for the entire evaluation period.

(4) The mission availability of the aircraft and weapons subsystems, excluding the AN/ASQ-132, was also determined. The mission availability considering only the UH-1M and M21 subsystems was 56%. The presence of the AN/ASQ-132 thus degraded mission availability by 7%. The small sample size provided during this evaluation should be kept in mind whenever any interpretation is made of these mission availability figures. Of the 94 days of the evaluation, 3 aircraft were present for 62 days, and 2 aircraft were present for 32 days.

(5) Average availability for the USARV UH-1C(A) fleet during the same period was 67%. The relatively lower UH-1M availability is attributed to the fact that the evaluation host unit was not provided additional maintenance support personnel when INFANT was attached. This amounted to a 25% maintenance workload increase for the host unit's already taxed maintenance capability and accounts for the 11% lower availability of the UH-1M when compared to the similar UH-1C(A).

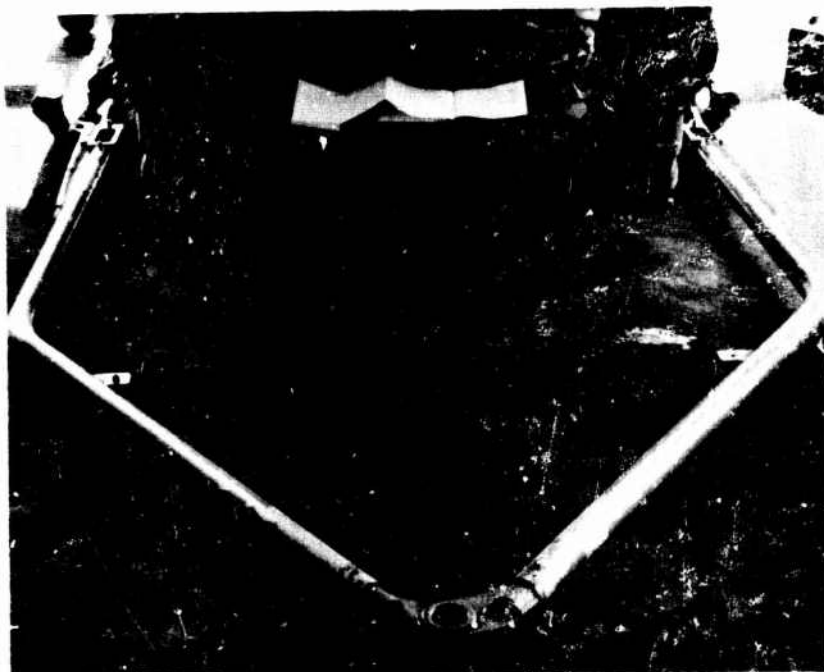
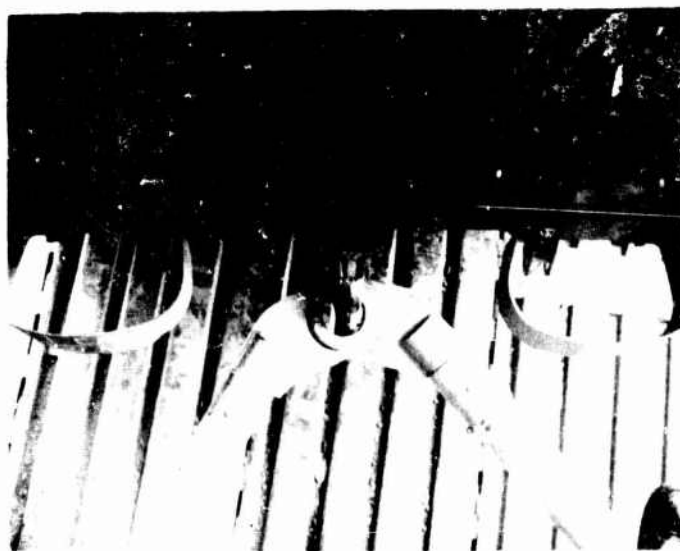
FIGURE 3-3. Standard Army Tow Bar (Modified for INFANT)

a. Rigid Tow Bar shown as it fits around INFANT Periscope Assembly

b. Widened Apex of Modified Tow Bar showing limited clearance between towing vehicle and bar

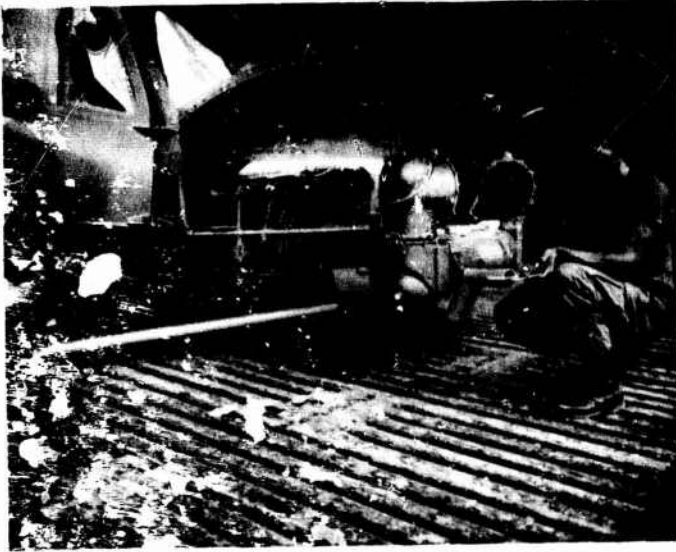
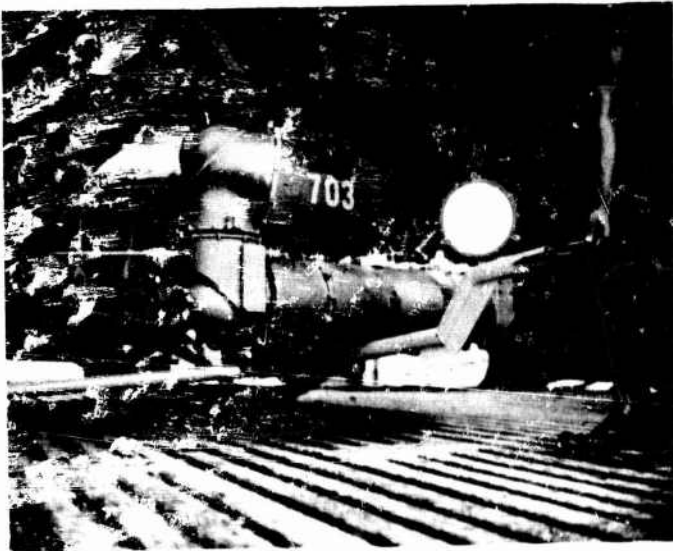
FIGURE 3-4. Contractor-Developed INFANT Tow Bar

- a. Position of the tow bar when towing vehicle is executing a turn is illustrated above. The pivot point beneath the avionics compartment flexes without causing the helicopter to turn.

- b. The position of the tow bar when towing vehicle is on ground slightly higher than the helicopter.

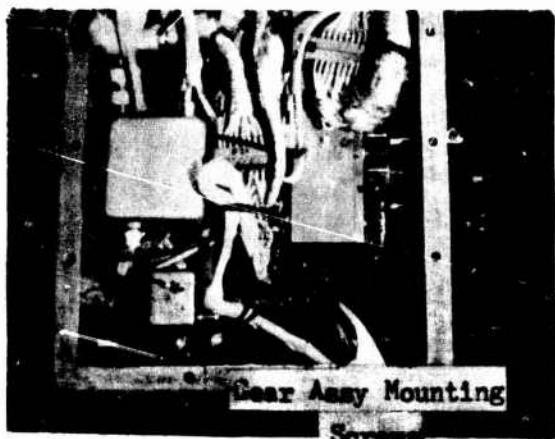
FIGURE 3-6. Location of Inaccessible Assembly Bolts

the cables were in a safe position. The inability to detect proper placement of cable was due to the fact that, as the HVPS is inserted, it blocks the only opening that allows a complete view of the cables. The addition of another opening, as indicated in Figure 3-9, could correct this situation. With the aid of this additional access, the HVPS could be installed and the necessary connection accomplished expeditiously.

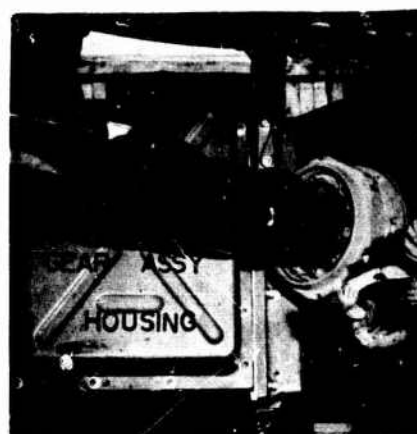
FIGURE 3-7. Inaccessible Gear Assembly Housing, Remote View Turret

e. Removal and Replacement of Periscope Gear Assemblies. Because of design characteristics, the DV periscope gear assembly mounting screws (Figure 3-6) were not easily accessible. An aggravated situation existed when working on the RV periscope gear assembly because the proximity of the fiber optic bundle (Figure 3-7) further reduced the working area. The fiber optic bundle hindered viewing the work area and created unusual working angles to gain access to the gear assembly. This corrective maintenance procedure was performed five times for a total of 86.5 hours.

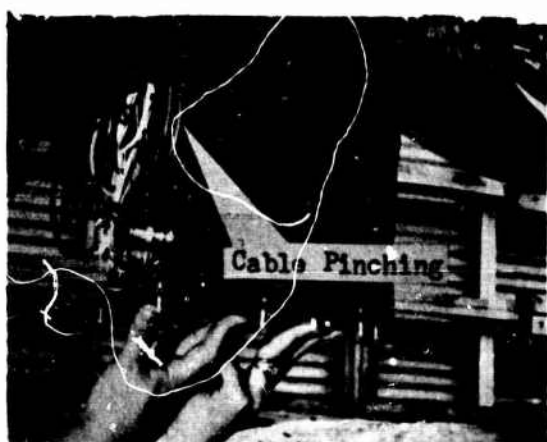
FIGURE 3-8. Cramped Cabling Around High Voltage Power Supply

f. High Voltage Power Supply (003 unit). During troubleshooting and maintenance checks of the AN/ASQ-132 subsystem, it often became necessary to disconnect and check the high voltage power supply (HVPS). To accomplish this, the HVPS was removed from the center casting of the periscope assembly. This unit was extremely difficult to reinstall. The high voltage leads, from both the RV and DV turrets, were connected into the HVPS. When inserting the HVPS into the center casting, the high voltage leads were often pinched as the component was secured in place (see Figure 3-8). This condition led to the failure of one or both sensors. Even though great care was taken, maintenance personnel could not be sure

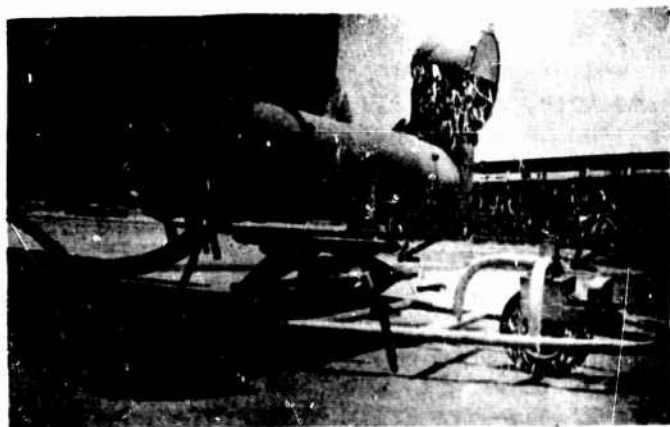
FIGURE 3-12. Weak points on Periscope Assembly Dolly

h. Dolly Transport of Periscope Assembly. When it was necessary to remove or install the AN/ASQ-132 periscope assembly, difficulty was experienced due to its weight (286 pounds) and the awkwardness and unreliability of the cradle-like dolly platform. The dolly (see Figure 3-12) was designed to lock onto the periscope assembly for the purpose of installation and removal from the aircraft. Once the periscope assembly has been disconnected from its helicopter mounting, it can be moved

on the steerable tricycle-wheel dolly. The NETT was supplied with three of these dollies. Even in good working condition the platforms were judged cumbersome and difficult to work with. The main problem was the automobile scissor-type jacks used to raise the cradle under the turret. Personnel adjusting the jacks often became confused with the direction of rotation, since the two cranks rotate in different directions when making the same adjustment. This characteristic resulted in jamming. The jacks were poorly constructed and broke (arrows) while being manipulated. The locking pin devices that secured the underside of the periscope assembly to the dolly (left arrow, Figure 3-12) were very difficult to operate in the close quarters of their location. In general, construction was judged poor from operational standpoint and weak (note arrows, Figure 3-12) from a materiel standpoint. After 3 months of use on semi-improved airfields, these devices were either broken or damaged to a point that their original capability was partially, if not totally, lost. The development of a dolly of improved design or modification of the present dolly is recommended in view of the high cost of the equipment it was designed to carry and hold.

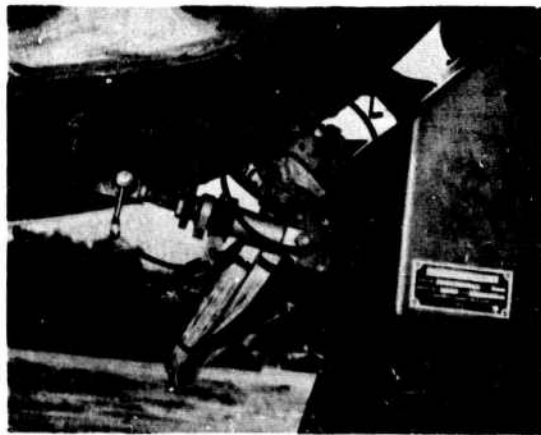
FIGURE 3-13. Deteriorated Cable Sleeve

d. The fabric sleeve used to prevent water from working up the AN/ASQ-132 cable harness between the periscope and helicopter fuselage (see Figure 3-13) deteriorated rapidly. This allowed the wind to force water into the helicopter avionics compartment when in flight.

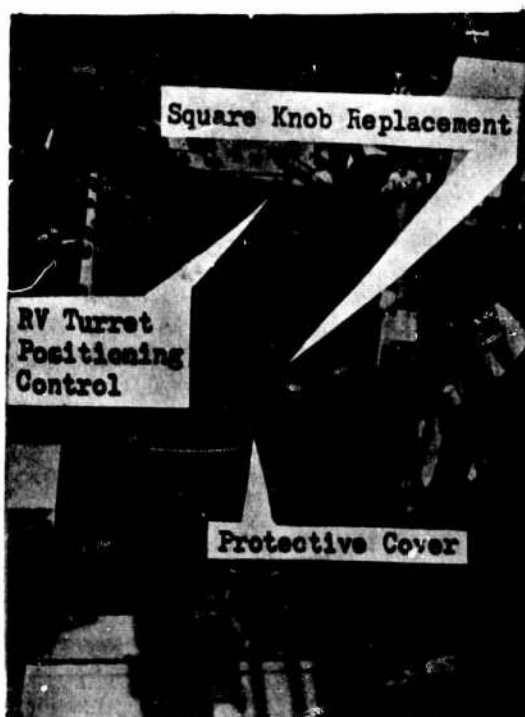
FIGURE 4-1. Field Expedient Modifications to Control Panel

a. One of the problems mentioned most frequently was that the AN/ASQ-132 controls (012 unit) on the helicopter pedestal were poorly located and identical in shape (see Figure 1-5, A-10, and A-11). Because the individual push buttons are difficult to differentiate by touch alone, several instances occurred in which operators inadvertently activated the "Off" and "Stow" buttons on the control panel when attempting to activate "Boresight" just prior to rocket firing. This resulted in abortion of rocket runs and, on occasion, caused the operator to lose visual contact with the target area during the turn-around for subsequent firing run. During the latter portion of the evaluation, a hinged sheet metal shield was fabricated and placed over the "Off" and "Stow" buttons (Figure 4-1). This modification prevented accidental activation of the wrong button.

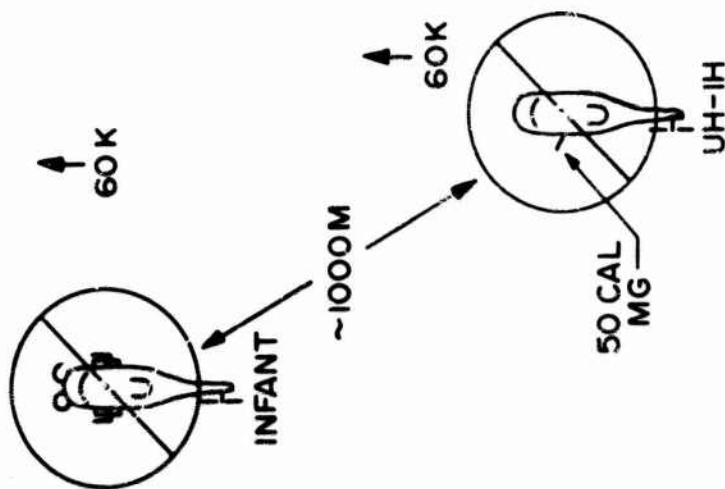
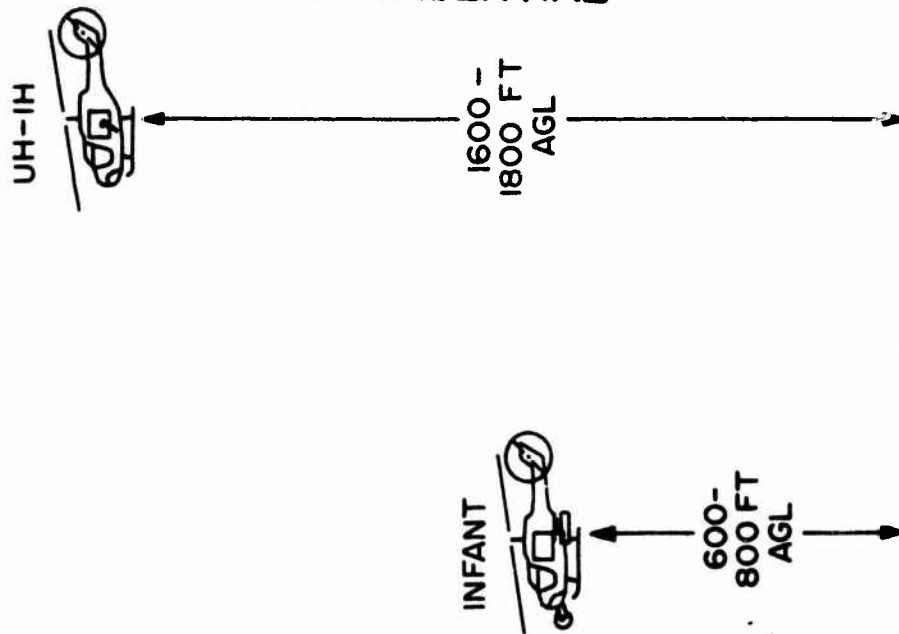
FIGURE 5-1. (C) INFANT and UH-1H (.50 Cal MG) (U)

a. INFANT and one UH-1H equipped with one door-mounted .50 cal machine gun. The UH-1H was used as a cover aircraft normally flying 1,000 feet above, slightly to the right of and approximately 1 km in trail of INFANT (see Figure 5-1). This technique and equipment combination was used most often during the evaluation.

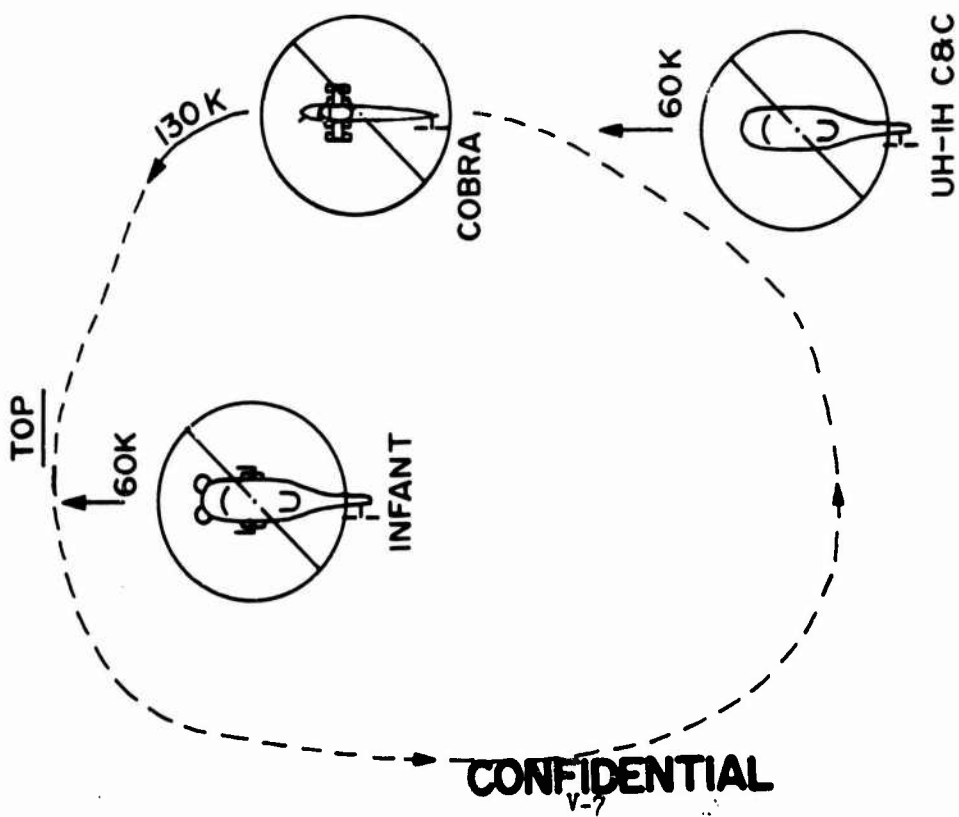
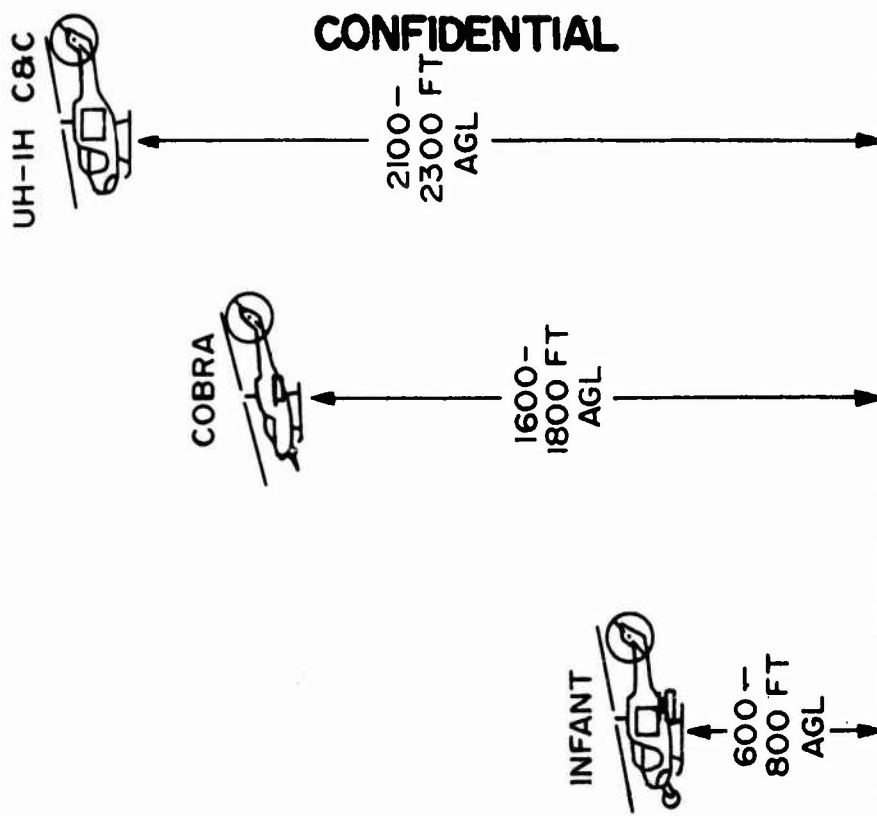
FIGURE 5-3. (C) INFANT, Hueycobra and UH-1H C&C (U)

c. INFANT, AH-1G Hueycobra, and one UH-1H. This configuration was employed numerous times and found to be very effective. The AH-1G flew 1000 feet above INFANT in an orbital pattern providing continuous air cover. The UH-1H was used as C&C at an altitude of 1500 feet above INFANT to provide maximum control of the two other aircraft (see Figure 5-3).

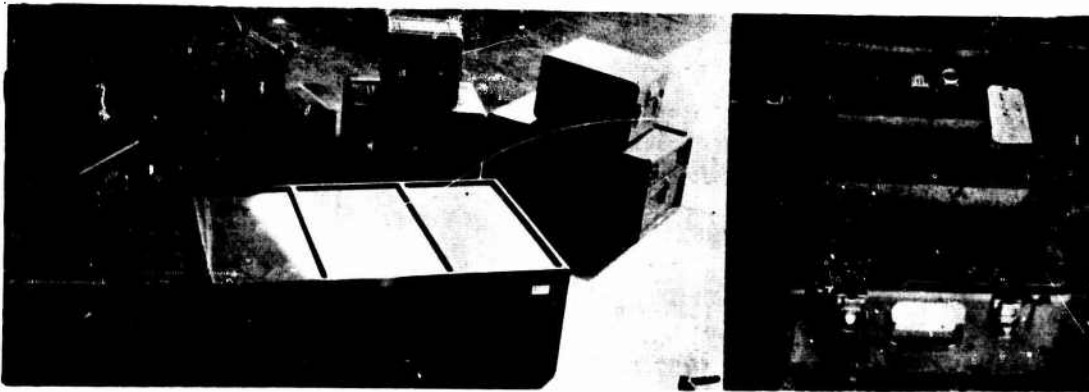
FIGURE A-2. AN/ASQ-132 Carrying Cases including inside view

Vendor Part No.	Stencil nomenclature	Hardware contained	Carrying case weight, including hardware (pounds)	Carrying case dimensions less clasps (inches)
D23183	Processor, signal data	008 unit	53	20x26x15
D23184	Amplifier, electronic control stabilization	009 unit	74	20x26x15.5
D23185	Power supply, low voltage Control, periscope positioning remote view Panel, control INFANT system	010 unit 011 unit 012 unit	50	17x21x18
D23186	Monitor, television, observer	902 unit	82	24x26x16.5
D23187	Monitor, television, pilot	903 unit (2)	79	24x26x16.5
D23188	Searchlight junction box, Searchlight cables, Searchlight	905 unit 904 unit (2)	107	20x26x18
D23189	Assembly, periscope	3166058 part of 001 unit	112	27x37x18.5
R23181	Periscope, tracking Direct view	004 unit and 3166486	225	42.5x69.5x22
R23546	Periscope, tracking Remote view	006 unit	165	29x45x20.5

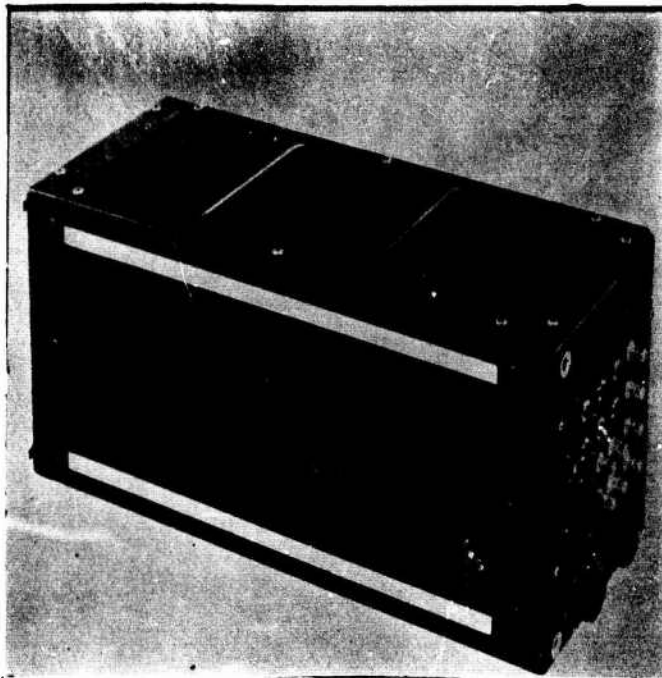
FIGURE A-7. Signal data processor (008 unit)

b. Signal Data Processor (008 unit) (Figure A-7) - The 008 unit is mounted in the system electrical rack (016 unit). It is housed in a metal case, both sides of which are removable to provide access to the chassis. The front panel contains a handle, two elapsed time meters, and two indicator lamps. The rear panel contains the 17 electrical connectors

for the unit. Circuits are contained on 13 removable cards and on the unit chassis. In addition, the unit has two spare circuit card locations and an extender card.

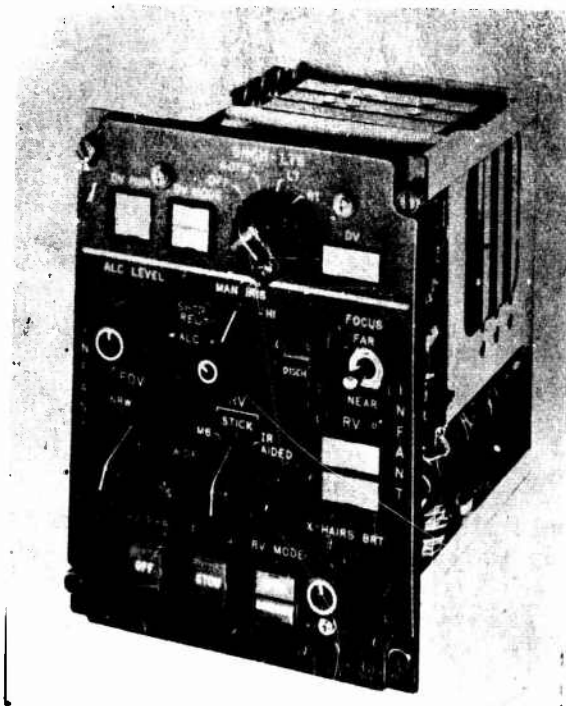
FIGURE A-11. AN/ASQ-132 system control panel (012 unit)

f. AN/ASQ-132 System Control Panel (012 unit) (Figure A-11) - The 012 unit is also mounted on the helicopter pedestal. It is housed in a metal case which has two holes in the back for electrical connectors. Electrical circuits are mounted on three removable cards and on the unit chassis. The front panel of the unit is of two-piece construction with components mounted on the back plate and the nomenclature engraved on the front plate. It is luminous to provide panel lighting. The unit may be removed from the pedestal by disengaging the four quarter-turn fasteners and disconnecting the two electrical cables at the rear.

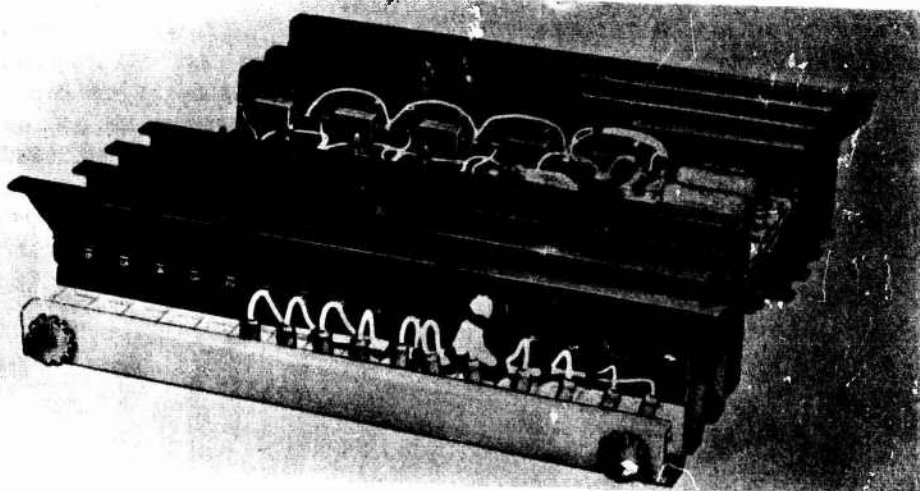
FIGURE A-12. Overvoltage absorber (017 unit)

h. Overvoltage Absorber (017 unit) (Figure A-12) - The 017 unit is mounted in the helicopter battery compartment. It consists of electrical components mounted on a dissipating heat sink. The unit has no case. A mounting bracket is provided at each corner of the heat sink to secure the unit.

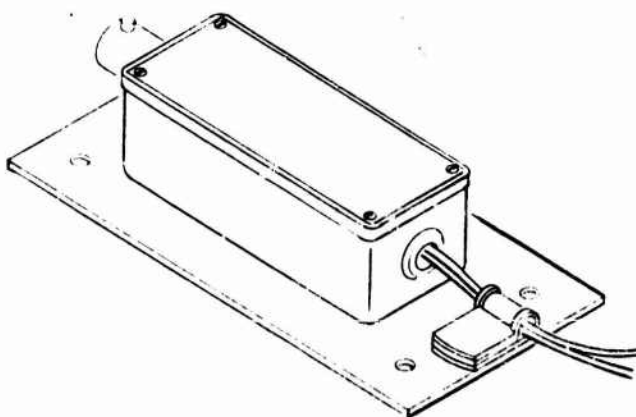
FIGURE A-13. Rocket flash protection (021 unit)

i. Rocket Flash Protection (021 unit) (Figure A-13) - The 021 unit is attached to the helicopter floor beneath the control pedestal by 4 bolts. The unit consists of a single circuit board completely enclosed for protection. It is attached to an aluminum alloy mounting plate. One end of the unit contains a coaxial plug. Two wires at the opposite end pass through a plastic clamp which provides strain relief.

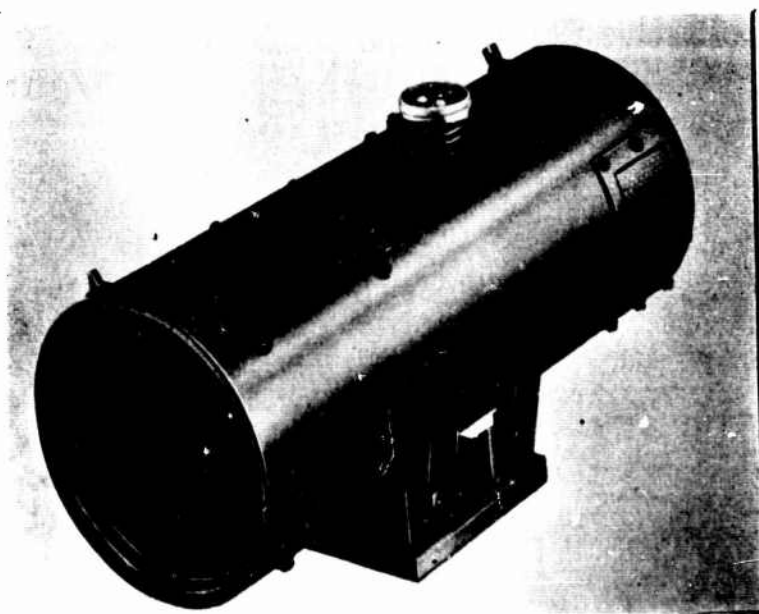
FIGURE A-16. Searchlight (904 unit)

case. The window of the searchlight incorporates a pink filter. The electrical connector for the 904 unit is located on top of the housing and allows a ± 5 degree adjustment in both azimuth and elevation. A blower draws cooling air into the unit through a port in the housing near the rear and exhausts through a port on the opposite side.

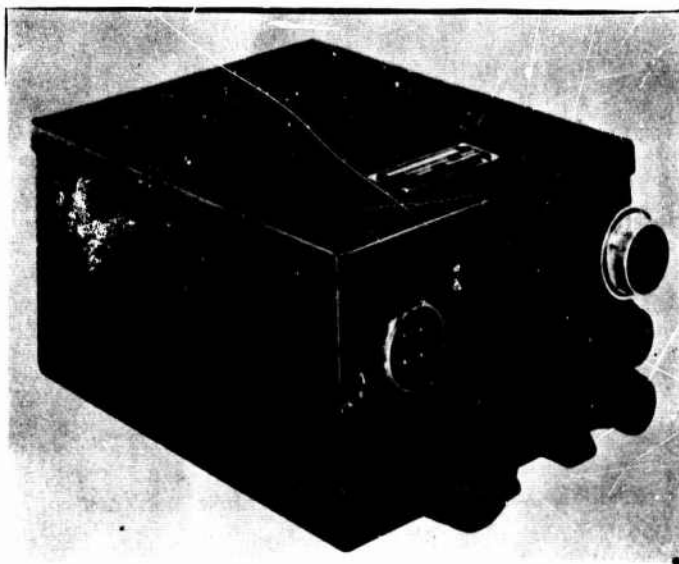
FIGURE A-17. Searchlight junction box
(905 unit)

m. Searchlight Junction Box (905 unit) (Figure A-17) - The 905 unit is housed in a metal case. The top of the case is removable to provide access to the electrical circuits inside. One end of the case contains two electrical connectors, two fuse holders and the blower. The other end of the case contains two electrical connectors and the inlet port for cooling air. Both ends of the case have two mounting flanges on the bottom side.

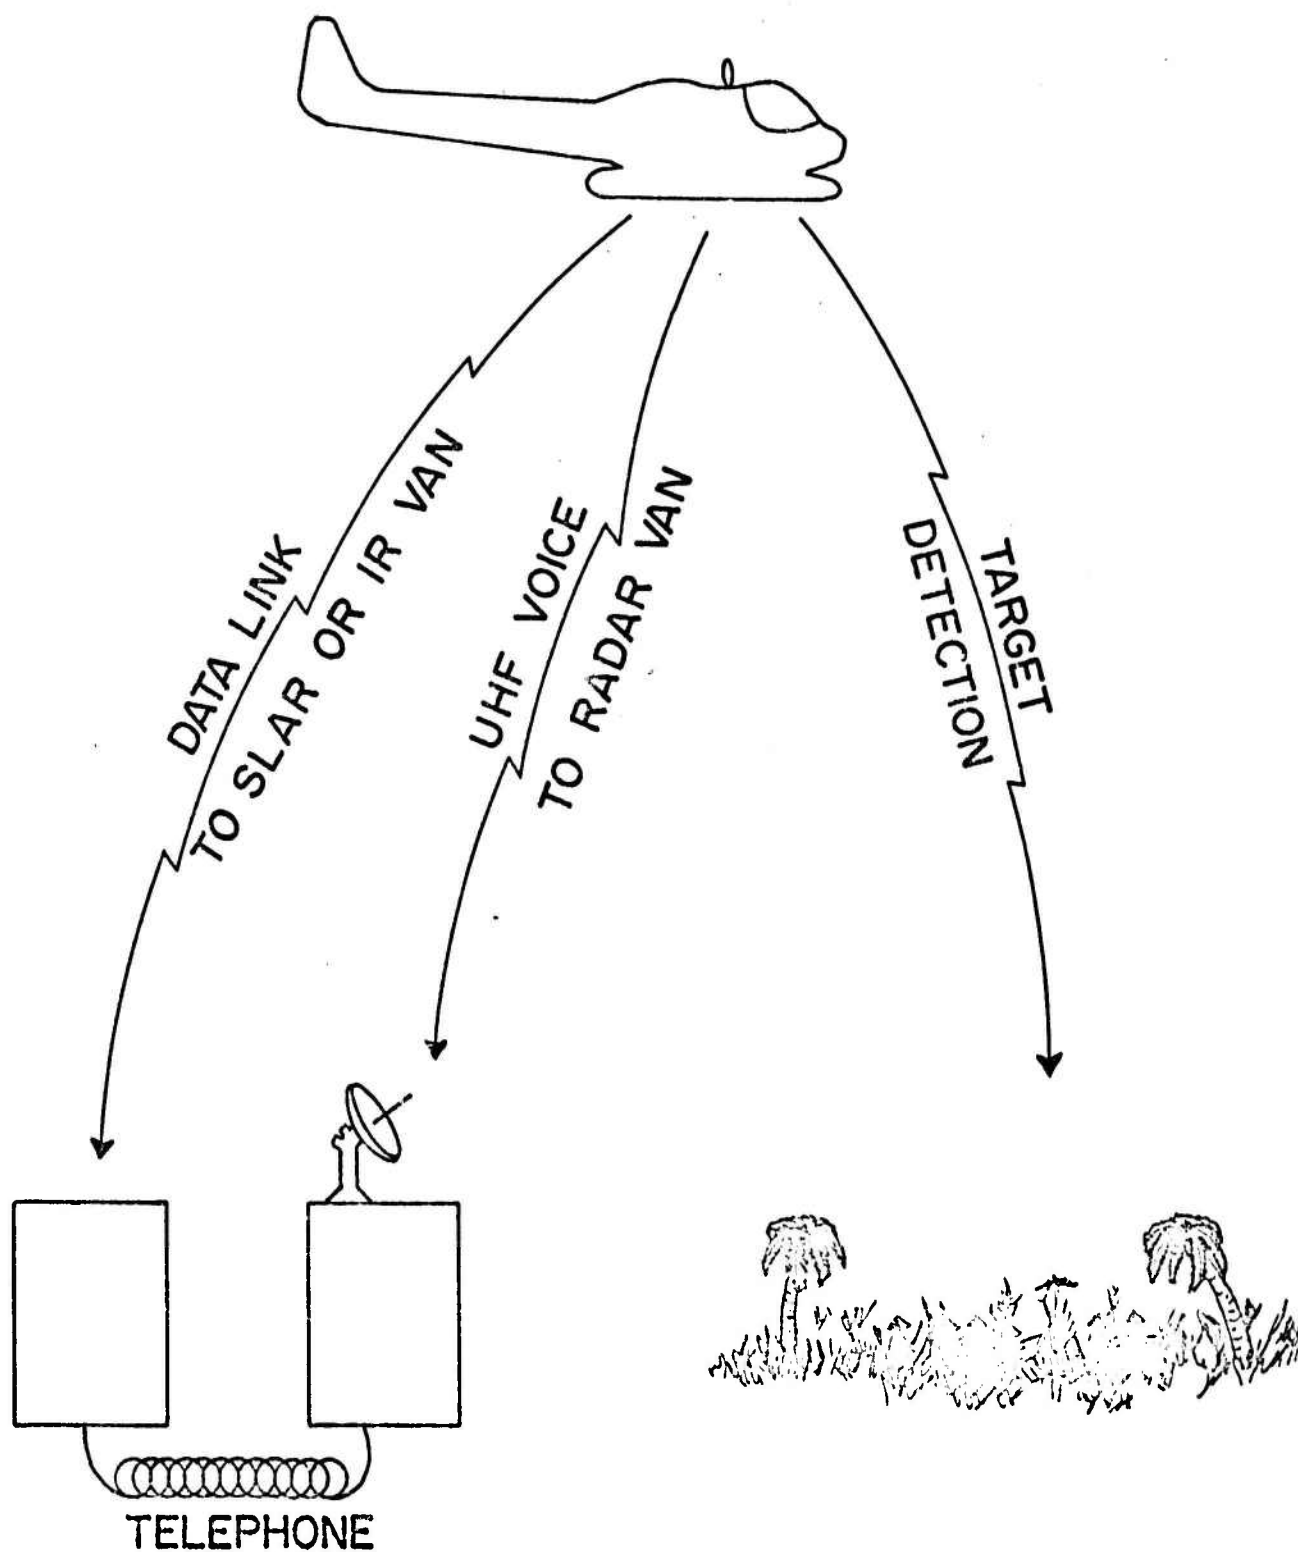
FIGURE K-2. Target Acquisition in Night Phantom Operation

4. To find the enemy, using the Night Phantom (INFANT) concept (see Figure K-2), an OV-1 Mohawk with IR or SLAR equipment flew in a pre-determined pattern over the area of interest; he was tracked by the radar. Target surveillance was monitored in the aircraft as well as at the data terminal station next to the radar van. The readout in the data terminal station is near real-time, and the accuracy is considered to be within 30 meters. Target coordinates were plotted in the radar van. The fire team would be scrambled based upon the number of targets and the size of a particular sighting.
